Aviation Safety

Letter

Issue 4/2001

Déjà Vu—Frost Causes Loss of Control

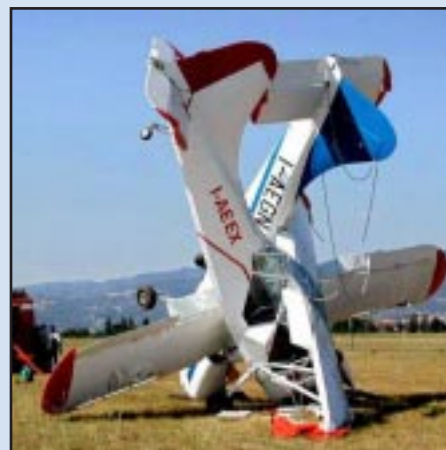
Two L5 glider tow planes lie stuck to one another on the grounds surrounding Rieti airfield in central Italy, Aug. 1, 2001, after they collided while flying over the area. The two pilots survived the crash with minor injuries.
